Keowee Home Services, LLC
Home Watch and Resident Project Management

Conner Monthly Inspection

Score	80.77%	Failed items	0	Actions	0
Audit Title	Conner Monthly Inspection				
Conducted on	8th Oct, 2020 8:44 AM EDT				
Prepared by	David Conner				
Location	6 Sextant Dr Salem SC 29676 United States (34.8059089947816, - 82.91099265225502)

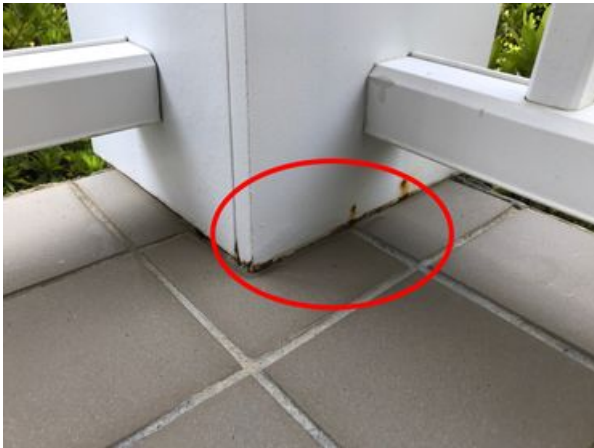
Photo 1

Check screens or porch enclosures for signs of damage

Water damage on front porch post continues to deteriorate. We recommend replacing soon.

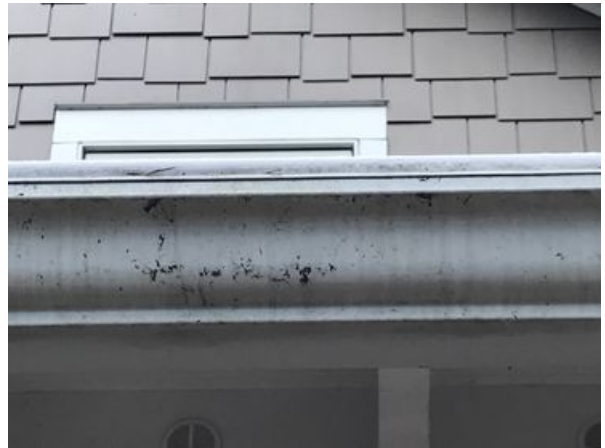
Photo 2

Check property for erosion or drainage problems

There is evidence that back gutters are full and overflowing to patio. We recommend that all gutters are cleaned once the leaves fall.

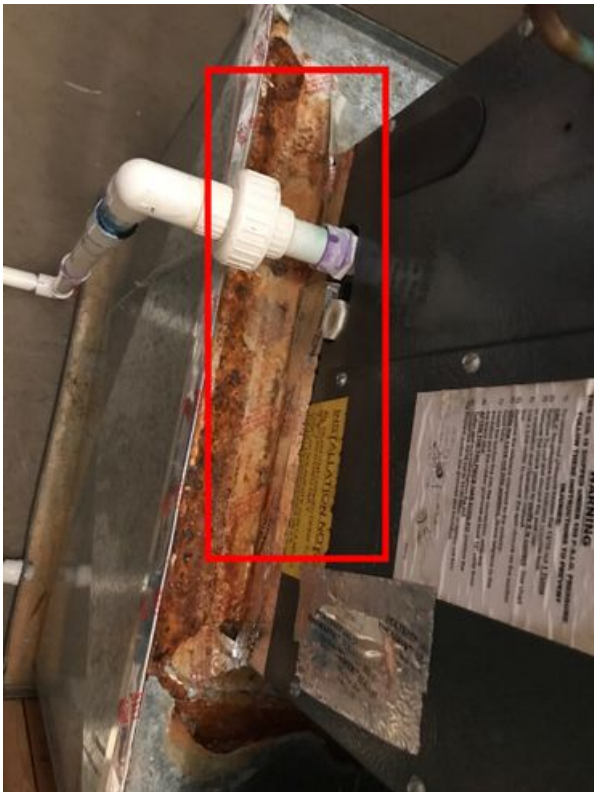
Photo 3

Visual check for leaks or stains around windows, ceilings, walks, water heaters, under sinks, around toilets

Evidence of drain leak with upstairs heat pump. Will be monitored on an ongoing basis for any continued issue.

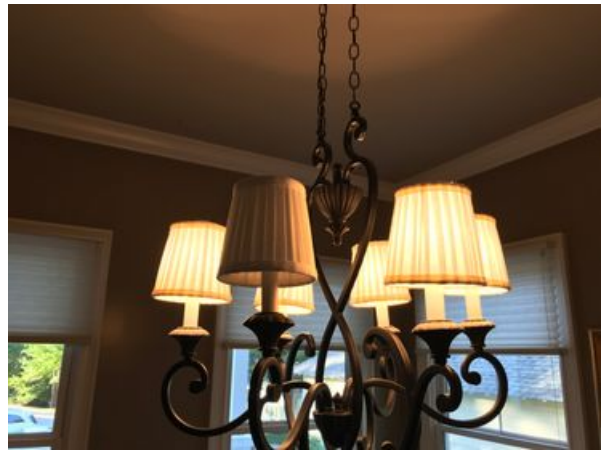
Photo 4

Turn on lights and fans throughout house

Bulb in dining room burned out. Replaced bulb with spare.

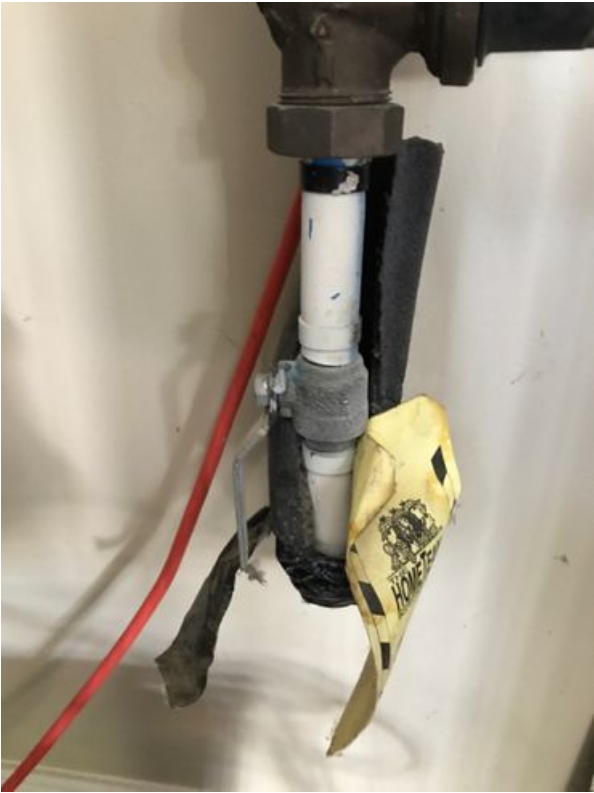
Photo 5

Water main left in the on position per the client.
